MSHA Safety Alert

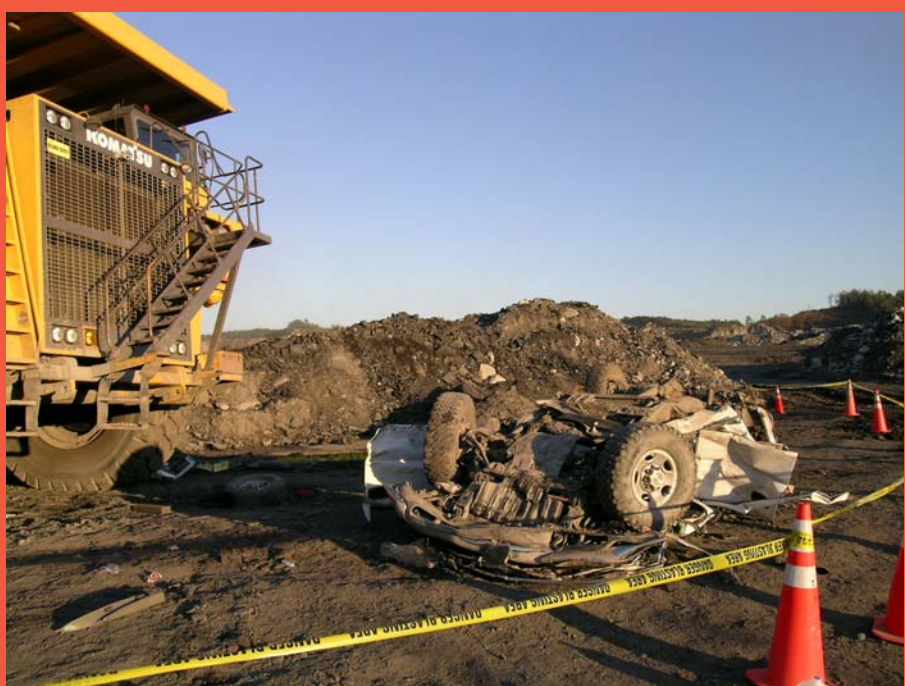
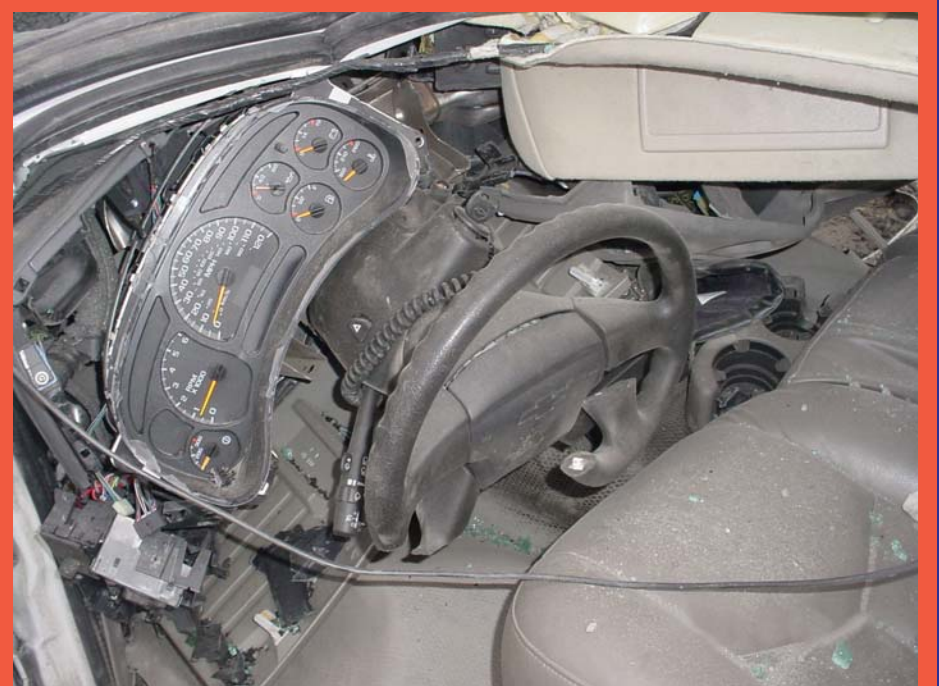
On September 30, 2005, a non-fatal accident occurred when a sport utility vehicle was struck by a large off-road haulage truck. The haulage truck operator had just completed a lunch break, when the truck was loaded and proceeded to leave the loading area. The haulage truck veered to the left, off of the regularly traveled route, and struck the sport utility vehicle. Upon impact, the smaller vehicle rolled over onto its top and became lodged beneath the front steering jacks of the haulage truck. The impact entrapped two persons within the sport utility vehicle. After approximately one hour, the two injured persons were rescued and transported to a hospital where they were treated and released the following day. There were no mechanical problems found with the haulage truck. The sport utility vehicle was equipped with a whip type antenna and a strobe light to increase its noticeability. Substance abuse is suspected as a possible factor in the cause of the accident.

- ✓ Equipment operators must remain diligent, alert, and cautious when small vehicular traffic is present.
- ✓ A minimum radius should be maintained free of equipment around all passenger vehicles.
- ✓ Always alert equipment operators, and wait for a reply, before entering active work areas.
- ✓ Haulage truck drivers should follow designated routes of travel.
